Analysis of Three UH-60 Blackhawk Servolink Components P/N 70400-08110-061

ARL-TR-2646

January 2002

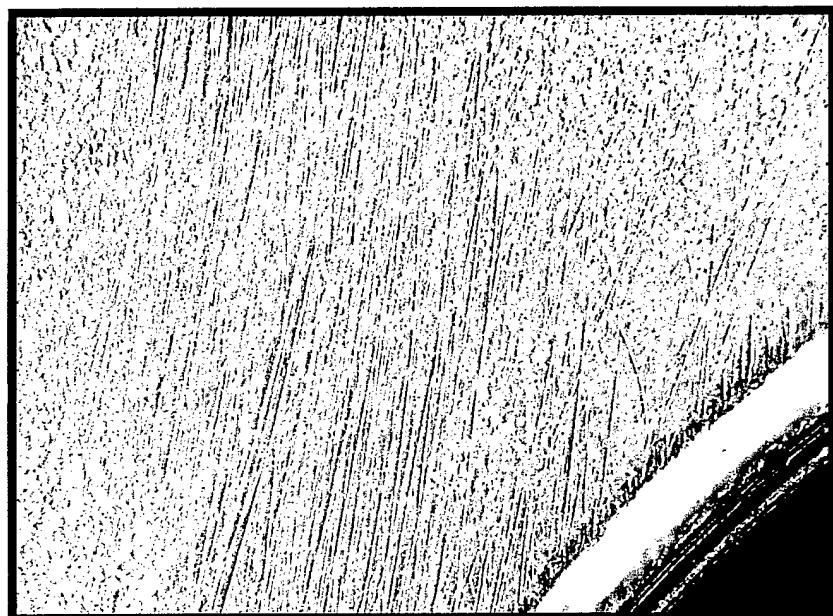
Figure 12. Scratches adjacent to the bearing on servolink 01268. Magnification 11.75x.
